From: Coordinator, Marine Corps Landing Force Development Activities,
(CMCS) Marine Corps Schools, Quantico, Virginia
To: Commandant of the Marine Corps (Code AX)
Subj: Project No. 51-58-03, Helicopter Cover; Final Report
Encl: (1) Final Report, Project No. 51-58-03

PROJECT NO: 51-58-03

SUBJECT: Helicopter Cover; final report

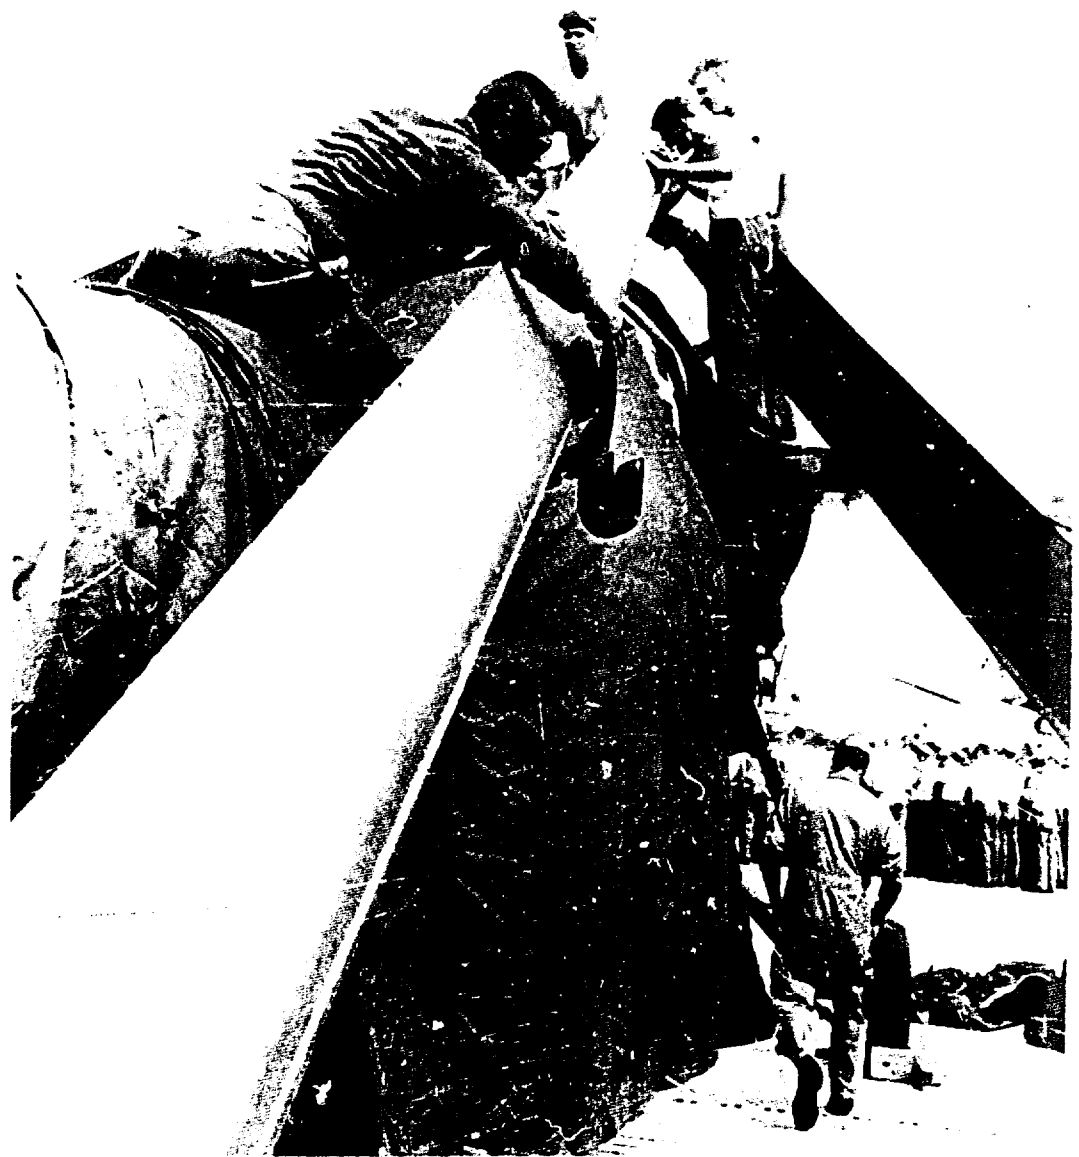
Fig 2

Positioning rotor blade cradle after
covering mid-section of fuselage.

(2) There were no indications of corrosion, staining, deterioration or wear on the helicopter or its component parts at the time the test commenced. Figures (1) through (4) (Annex B) depict the installation proceedings.
